**Flood Control Project Maintenance  
Levee Inspections**

**Fall 2016 Levee Maintenance Deficiency Summary Report**

**Sacramento River Basin**

**Sutter Maintenance Yard Maintenance Area 0013**

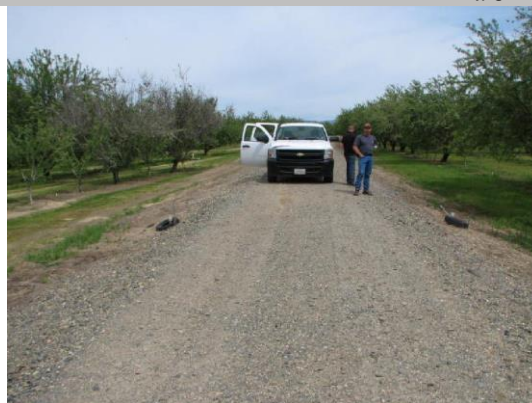
Photo 1 of 2 : UCIP\_FA\_2016\_50973\_66680.jpg

Comment Code					
Inspector Comment					
FS_ID:50973 DS_ID:16327 EP_NO: 6135 Repair Type: Urgent Crossing Status: Found UCIP Comments: 11/16/2016 Appears no repairs have been made here yet as LS slope is still dug away. (DWR Sutter Yard-AFreitag)4/28/2016 8-inch pipe was running water but was leaking at a weld joint on the LS slope. Pipe appears to have been dug out by the landowner but unsure if repairs are being made yet. (see photo 5)7/14/2015 Pipe end is still welded solid.5/21/2014 Same as last inspection.12/2/2013 Same as last inspection.7/10/2013 Same as last inspection. FIELD_STRUCT_DESC: 8-inch steel irrigation pipe through the levee 2.8 feet below the crown. Permit requirements are as follow: during the flood season the 5-inch irrigation pipe will be removed and a plate bolted over the waterside (WS) end of the 8-inch. Pipe section is completely buried. Current configuration does not allow for 5-inch irrigation pipe to slide pipe through. 8-inch pipe is welded solid. (Permit No. 6135, 1968 - George Washington) [Additional Reference(s): DWR Levee Log, 1993] FS Date: 11/28/2016 8:45:31 AM

Overview of the crossing.

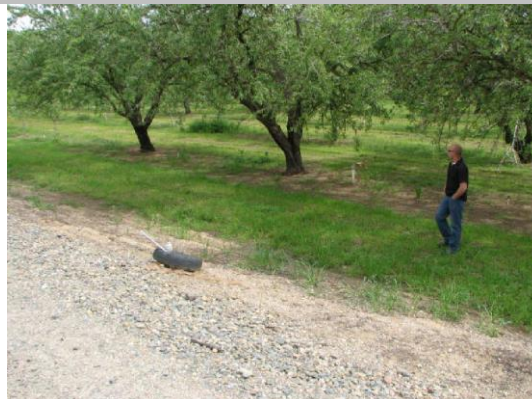
Photo 2 of 2 : UCIP\_FA\_2016\_50973\_66683.jpg

Air Vent located on WS.

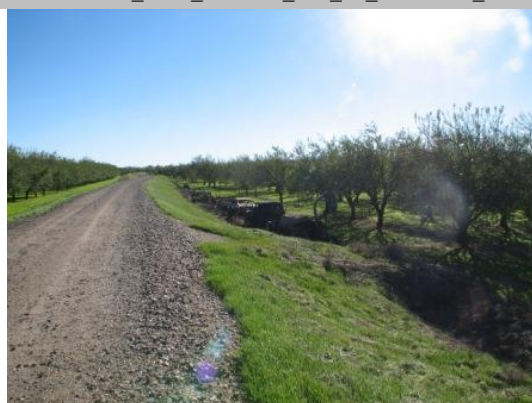
Photo 1 of 1 : FA\_2016\_MA0013\_300\_12\_20160823\_00006.jpg

View of the equipment along the landside toe of the levee.

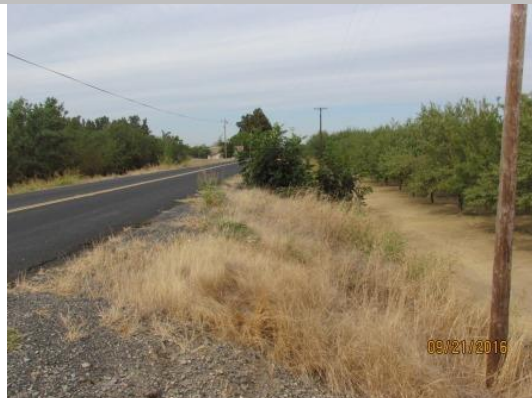
Photo 1 of 1 : FA\_2016\_MA0013\_300\_52\_20161010\_00080.jpg

View of the vegetation along the landside slope.

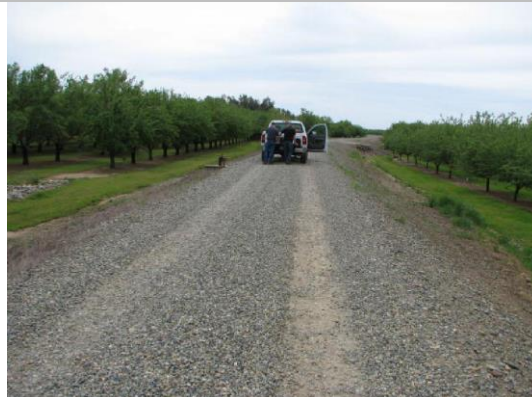
Photo 1 of 2 : UCIP\_FA\_2016\_50976\_66695.jpg

FS\_ID:50976  
DS\_ID:16831  
EP\_NO: N/A  
Repair Type: Urgent  
Crossing Status: Found  
UCIP Comments: 11/16/2016 WS structures still removed. (DWR Sutter Yard- AFreitag)10/17/2016 Landowner removed WS concrete headwall and pipe section through floodway to make room for orchard. The area disturbed appears to be from WS toe to where the mature trees are located within floodway, approximately 45 feet from WS toe. Crossing is classified as Urgent with potential levee integrity issues due to the disturbance of the WS without prior approval from the CVFPB. (DWR UCIP - omagana)  
4/28/2016 Landowner appears to have removed the WS headwall and pipe to make room for planting more orchard trees. LS pipe end was full of water as it has no where to drain to anymore. Changing to urgent listing but it currently does not affect the levee integrity. (see photos 8, 9, & 10) (DWR Sutter Yard - afreitag)7/14/2015 Crossing appears in good condition. No noticeable issues to report. (DWR Sutter Yard - afreitag)5/21/2014 Same as last inspection. (DWR Sutter Yard - afreitag)12/2/2013 Pipe section was dug up and repaired. Crossing is now in good condition. (DWR Sutter Yard - afreitag) 4/17/2012 Pipe collapse on WS 10 feet from toe, needs repair. From WS, sediment is visible inside pipe. (DWR UCIP - omagana)

Overview of levee crown at crossing looking downstream.

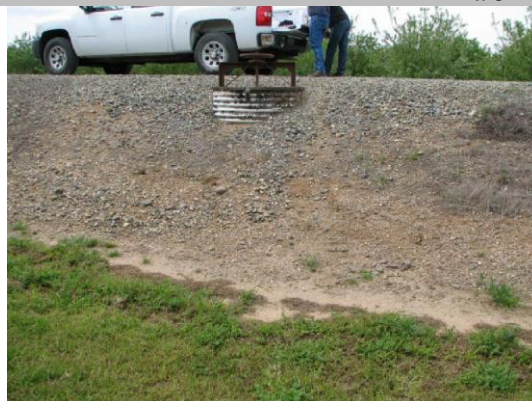
Photo 2 of 2 : UCIP\_FA\_2016\_50976\_66699.jpg

Corrugated metal riser with slide gate located on WS slope.

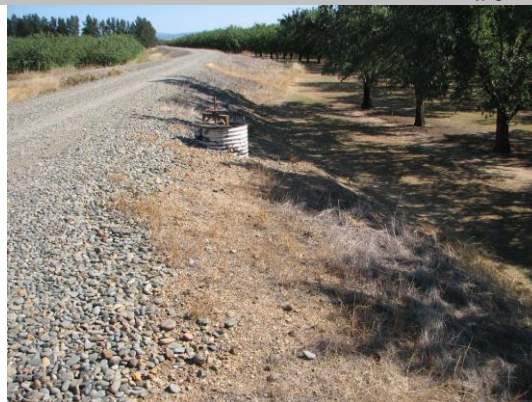
Photo 2 of 2 : UCIP\_FA\_2016\_50977\_66704.jpg

Inspector Comment
<p>FS_ID:50977 DS_ID:16345 EP_NO: N/A Repair Type: Non-Urgent Crossing Status: Found UCIP Comments: 11/16/2016 PVC pipe still present blocking the screw gate. (DWR Sutter Yard- AFreitag)4/28/2016 Pvc pipe is still present through the crossing. Slide gate cannot shut fully.7/14/2015 4-inch pipe still present and blocking the screw gate.5/21/2014 Same as last inspection.12/2/2013 Same as last inspection.7/15/2013 Same as last inspection.4/17/2012 Crossing has 4-inch pipe inside blocking positive closure/notify landowner to remove prior to flood season. LS crossing is blocked about 50% by sediment build up. Burrow activity present on LS near crossing. FIELD_STRUCT_DESC: 24-inch corrugated metal irrigation pipe through the levee, 7.6 feet below the crown. Slide gate in corrugated metal pipe (CMP) riser on the waterside (WS) slope. Concrete headwall on the landside (LS). 36-inch concrete standpipe in the channel with 2 piles to deflect debris. [Additional Reference(s): DWR Levee Log, 1993. USACE Sacramento O&amp;M Manual 519, June 1962 (HLM 1.69)] FS Date: 11/28/2016 9:13:39 AM</p>

WS view looking upstream.

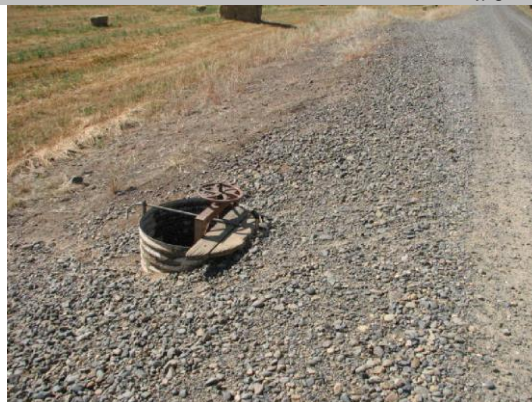
Photo 2 of 2 : UCIP\_FA\_2016\_50978\_66709.jpg

FS\_ID:50978  
DS\_ID:16346  
EP\_NO: N/A  
Repair Type: Non-Urgent  
Crossing Status: Found  
UCIP Comments: 11/16/2016 Appears abandoned. Unable to find anything on LS. (DWR Sutter Yard- A Freitag)4/28/2016 Appears to be an abandoned crossing. LS headwall and pipe inlet are still completely buried.7/14/2015 Still cannot find an inlet or outlet.5/21/2014 Same as last inspection.12/2/2013 Same as last inspection.7/15/2013 Same as last inspection.4/17/2012 Non functional crossing due to LS headwall buried. This crossing was listed in the USACE Periodic Inspection report as Corp's inspect ID#USACE\_CESPK\_M13D\_2011\_p\_0119 for no inlet or outlet visible. FIELD\_STRUCT\_DESC: \*ABANDONED\* 24-inch corrugated metal irrigation pipe through the levee 7.8 feet below the crown. Slide gate in corrugated metal pipe riser on the waterside (WS) slope. Pipe continues across channel. Concrete "U" headwall on the landside (LS). [Additional Reference(s): DWR Levee Log, 1993. USACE Sacramento O&M Manual 519, June 1962 (HLM 2.35)]

Corrugated riser located on WS slope.

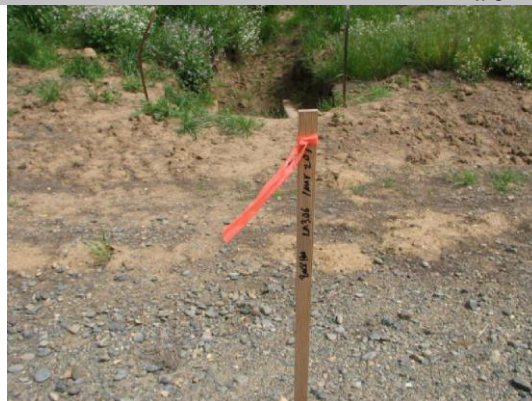
Photo 2 of 2 : UCIP\_FA\_2016\_50980\_66716.jpg

FS\_ID:50980  
DS\_ID:17372  
EP\_NO: N/A  
Repair Type: Non-Urgent  
Crossing Status: Found  
UCIP Comments: 11/16/2016 Pipe about 50% full of sediment. (DWR Sutter Yard- A Freitag) 4/28/2016 Pipe on LS is about 50% full of sediment. There is now a concrete pipe that discharges into the LS inlet of this crossing. Not sure where the concrete pipe comes from. 7/14/2015 Crossing appears in good condition. No noticeable issues to report. 5/21/2014 Same as last inspection. 12/2/2013 Pipe section was dug up and repaired. Crossing is now in good condition. 7/15/2013 Pipe appears to have a possible hole in top of pipe about 10ft. in from LS headwall. 4/17/2012 LS headwall blocked by sediment (50 % of opening is covered). LS floor is higher than LS pipe invert. WS headwall has been recently cleared of vegetation and sediment. This crossing was listed in the USACE Periodic Inspection report as Corp's inspect ID#USACE\_CESPK\_M13D\_2011\_p\_0157 for WS and LS inlet/outlet blocked by sediment.

WS levee slope.

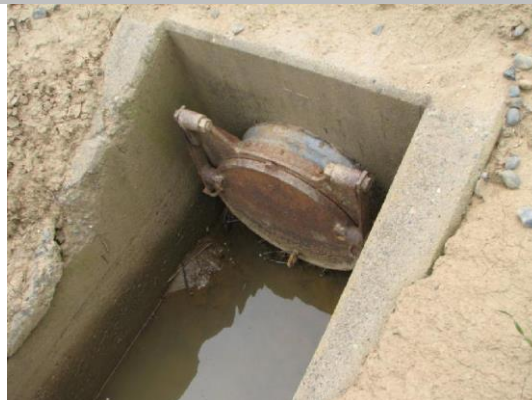
Photo 2 of 2 : UCIP\_FA\_2016\_50982\_66724.jpg

FS\_ID:50982  
DS\_ID:16349  
EP\_NO: N/A  
Repair Type: Non-Urgent  
Crossing Status: Found  
UCIP Comments: 11/16/2016 Both gates closed but partially buried and unable to open. (DWR Sutter Yard- AFreitag)4/28/2016 Sediment build up on both gates blocking them from operating properly.7/14/2015 Crossing appears in good condition. No noticeable issues to report.5/21/2014 Same as last inspection.12/2/2013 Same as last inspection.7/15/2013 Stem on LS screw gate has been replaced and is now full functional.4/17/2012 LS slide gate stem is bent and prevents gate from fully closing. Both WS and LS have been cleared of debris and sediment. This crossing was listed in the USACE Periodic Inspection report as Corp's inspect ID#USACE\_CESPK\_M13D\_2011\_p\_0162 for inoperable gates on WS & LS due to sediment and grass blocking inlet and outlet.  
FIELD\_STRUCT\_DESC: 24-inch corrugated metal drainage pipe through the levee, 8.9 feet below the crown. Concrete "U" headwalls on both the waterside (WS) and landside (LS) ends. Flap gate visible on the waterside (WS) end. [Additional Reference(s): DWR Levee Log, 1993. USACE Sacramento O&M Manual 519, June 1962 (HLM 3.29)]

Flap gate on WS.

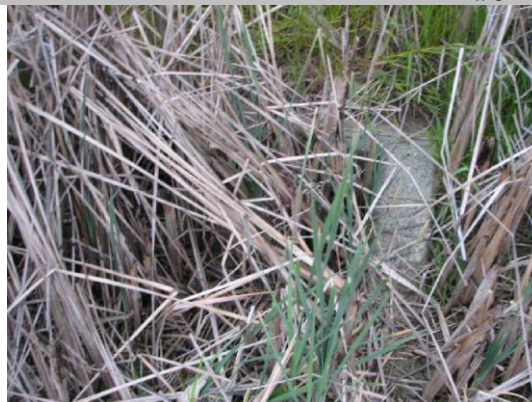
Photo 2 of 2 : UCIP\_FA\_2016\_50985\_66741.jpg

FS\_ID:50985  
DS\_ID:16365  
EP\_NO: N/A  
Repair Type: Non-Urgent  
Crossing Status: Found  
UCIP Comments: 11/16/2016 Both LS and WS gates buried. (DWR Sutter Yard- A Freitag) 4/28/2016 Abandoned crossing. Ls screw is still bent and mostly buried. 7/14/2015 LS screw gate is still damaged and buried. Crossing is non-functional. 5/21/2014 Same as last inspection. 12/2/2013 Same as last inspection. 7/15/2013 Slopes have been cleared of vegetation and are in good condition. LS screw gate is still bent and silted over. 4/18/2012 LS slide gate covered with silt. Slide gate is bent. Crossing appears not be in use. Limited inspection on WS and LS slope due to dense vegetation. Need photos of cleared slopes.  
FIELD\_STRUCT\_DESC: \*ABANDONED\* 24-inch corrugated metal drainage pipe through the levee, 7.9 feet below the crown. Flap gate on the waterside (WS) end. Screw gate on the landside (LS) end. Concrete "U" headwalls on both ends. [Additional Reference(s): DWR Levee Log, 1993. USACE Sacramento O&M Manual 519, June 1962 (HLM 3.82)]

WS flap gate blocked by debris.

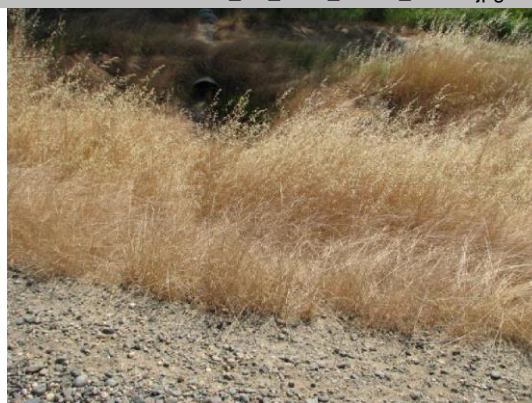
Photo 2 of 2 : UCIP\_FA\_2016\_50992\_66765.jpg

FS\_ID:50992  
DS\_ID:16357  
EP\_NO: N/A  
Repair Type: Non-Urgent  
Crossing Status: Found  
UCIP Comments: 11/16/2016 WS flap gate closed but blocked from opening by sediment. (DWR Sutter Yard- A Freitag) 4/28/2016 WS flap gate blocked from opening by sediment. 7/13/2015 WS flap gate is blocked from opening by sediment. Needs to be dug out. 5/21/2014 Same as last inspection. 12/2/2013 Same as last inspection. 7/15/2013 Slopes have been cleared of vegetation and are in good condition. 4/18/2012 Limited inspection on WS and LS slopes due to dense vegetation. Need photos of cleared slopes.  
FIELD\_STRUCT\_DESC: 24-inch corrugated metal drainage pipe through the levee, 8.6 feet below the crown. Flap gate on the waterside (WS) end. Concrete "U" headwalls on both ends. [Additional Reference(s): DWR Levee Log, 1993. USACE Sacramento O&M Manual 519, June 1962 (HLM 5.48)]  
FS Date: 11/28/2016 10:50:24 AM

View of WS slope and channel.

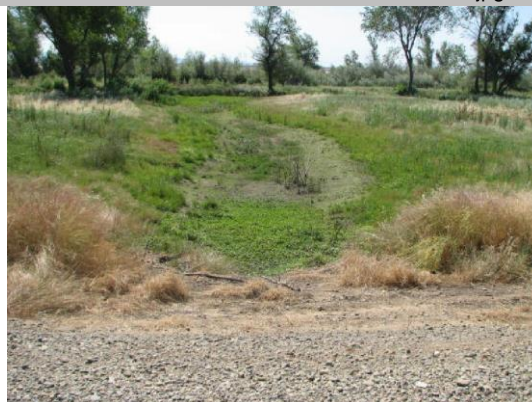
Photo 2 of 2 : UCIP\_FA\_2016\_47642\_66794.jpg

Comment Code					
Inspector Comment					
FS_ID:47642 DS_ID:16359 EP_NO: N/A Repair Type: Non-Urgent Crossing Status: Found UCIP Comments: 4/28/2016 WS gate and headwall are buried. Only the top of the headwall was visible. LS appeared ok.7/13/2015 Both the LS screw gate and WS flapgate are completely buried.5/21/2014 Same as last inspection.12/2/2013 Same as last inspection.7/15/2013 Slopes have been cleared of vegetation and are in good condition. WS headwall and flapgate are fully covered in debris and not visible. Need to clear.4/18/2012 High sedimentation build up at WS and LS headwall. Limited inspection due to dense vegetation on WS and LS slope. Need photo of cleared WS and LS slopes. This crossing was listed in the USACE Periodic Inspection report as Corp's inspect ID# USACE_CESPK_M13D_2011_p_0210 for WS gate submerged. FIELD_STRUCT_DESC: 24-inch corrugated metal drainage pipe through the levee, 9.2 feet below the crown. Flap gate on the waterside (WS) end. Concrete "U" headwalls on both ends. [Additional Reference(s): DWR Levee Log, 1993. USACE Sacramento O&M Manual 519, June 1962 (HLM 5.73)] FS Date: 5/4/2016 8:56:00 AM

View of WS slope and toe.

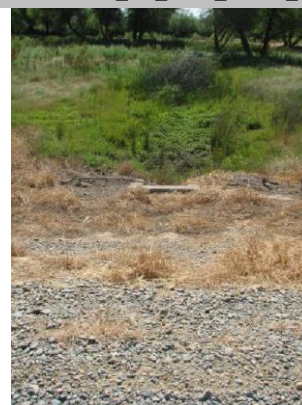
Photo 2 of 2 : UCIP\_FA\_2016\_47644\_66806.jpg

FS\_ID:47644  
DS\_ID:16361  
EP\_NO: N/A  
Repair Type: Non-Urgent  
Crossing Status: Found  
UCIP Comments: 4/28/2016 LS screwgate is still completely buried.

View of WS slope and toe.

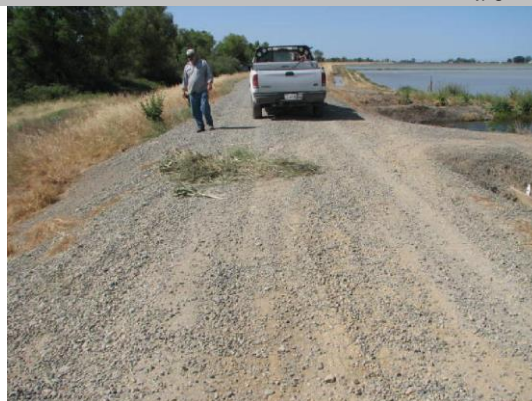
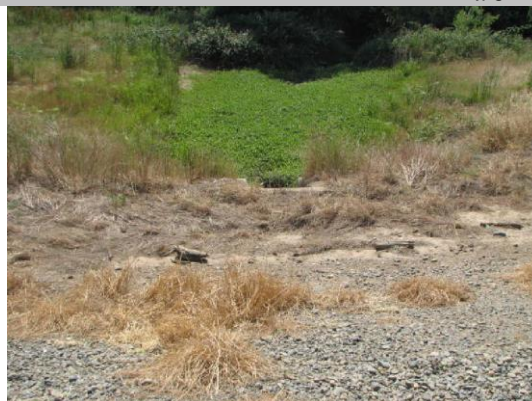
Comment Code					
Inspector Comment					
FS_ID:49923 DS_ID:16362 EP_NO: 5200B Repair Type: Urgent Crossing Status: Found UCIP Comments: 4/28/2016 Hole still present behind the LS flashboards. Rest of the crossing appeared in good condition. (DWR Sutter Yard - afreitag)7/13/2015 Hole still present behind the LS flashboards. (DWR Sutter Yard - afreitag)5/21/2014 Same as last inspection. (DWR Sutter Yard - afreitag)12/2/2013 Same as last inspection. (DWR Sutter Yard - afreitag)7/15/2013 WS slope has been cleared of vegetation and is in good condition. Hole is still present behind flash boards on LS. (DWR Sutter Yard - afreitag)4/18/2012 Hole behind flashboards against slide gate on LS slope (Health and Safety Issue). Limited inspection on WS slope due to dense vegetation. Need photo of cleared slope on WS. (DWR UCIP - omagana) FIELD_STRUCT_DESC: 24-inch corrugated metal drainage pipe through the levee, 7.8 feet below the crown. Flap gate on the waterside (WS) end. Slide gate on the landside (LS) end. Concrete headwall on both ends (Permit No. 5200B - 1965, Richvale Irrigation District) (Additional Related Permit(s): Permit No. 5200 and 5200A) [Additional Reference(s): DWR Levee Log, 1992. USACE Sacramento O&M Manual 519, June 1962 (HLM 6.56)] FS Date: 5/4/2016 9:02:00 AM

Overview of levee crown at crossing looking downstream.

View of WS slope and toe.

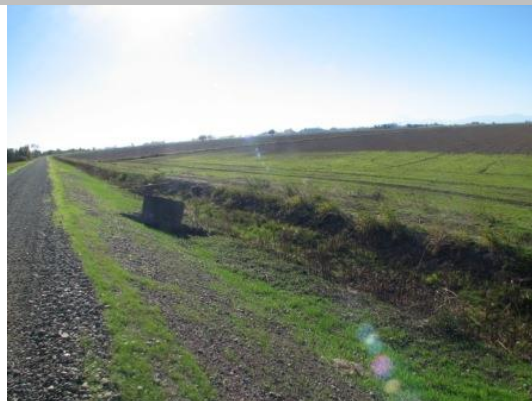
Photo 1 of 1 : FA\_2016\_MA0013\_300\_2\_20160823\_00001.jpg

LM Start	6.53	Rating **	M	Issue No.	2
LM End	6.53	Issue Type +	En	Location *	LS
Category	Earthen Levee			GPS Latitude/Longitude	
				Start	End
Item	Encroachments			39.507337 °	39.507337 °
				-121.715693 °	-121.715693 °
DWR ID	DWR_MA0013_01_s_2012_2				
Comment Code					
MA : Material					
Inspector Comment

View of a concrete block along the toe.

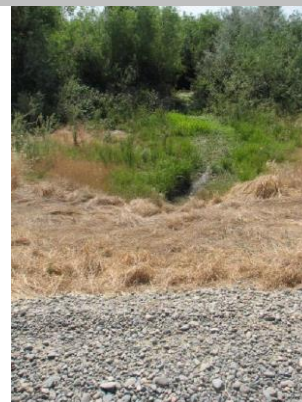
Photo 2 of 2 : UCIP\_FA\_2016\_47689\_66832.jpg

Comment Code					
Inspector Comment					
FS_ID:47689 DS_ID:16329 EP_NO: N/A Repair Type: Non-Urgent Crossing Status: Found UCIP Comments: 4/28/2016 LS slide gate is still bent. Everything else with the crossing appeared ok.7/13/2015 LS screw gate needs to be replaced. Everything else with crossing seems to be in good condition.5/21/2014 Same as last inspection.12/2/2013 Same as last inspection.7/15/2013 Slopes have been cleared of vegetation and are in good condition. There were no apparent signs of settling. LS screw gate is still damaged.4/18/2012 LMA's inspection sheet of 2011 indicates settlement and visible corrosion. Damage/severe corrosion on screw gate where it bolts to headwall. No visible signs of settlement due to high vegetation cover. Limited inspection on WS and LS slopes due to dense vegetation. Need photos of cleared slopes for this crossing. FIELD_STRUCT_DESC: 24-inch corrugated metal drainage pipe through the levee, 9.8 feet below the crown. Flap gate on the waterside (WS) end. Slide gate on the landside (LS) end. Concrete headwall on both ends. [Additional Reference(s): DWR Levee Log, 1993. USACE Sacramento O&M Manual 519, June 1962 (HLM 7.10)] FS Date: 5/4/2016 9:11:00 AM

View of WS slope and toe.

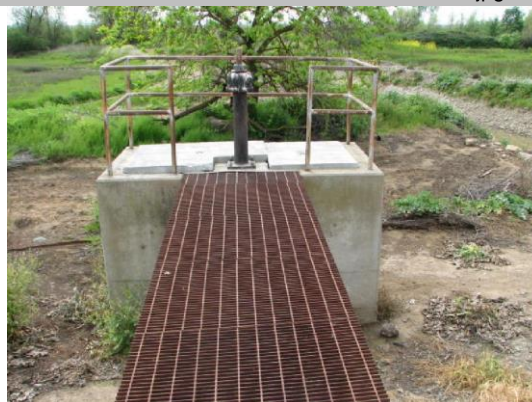
Photo 2 of 2 : UCIP\_FA\_2016\_49924\_66884.jpg

FS\_ID:49924  
DS\_ID:16323  
EP\_NO: N/A  
Repair Type: Urgent  
Crossing Status: Found  
UCIP Comments: 4/28/2016 Erosion still present at the LS headwall.  
(DWR Sutter Yard - afreitag)7/13/2015 Erosion still present behind the LS headwall. It looks to be getting worse and is starting to affect the levee slope. (DWR Sutter Yard - afreitag)5/21/2014 Same as last inspection. (DWR Sutter Yard - afreitag)12/3/2013 Same as last inspection. (DWR Sutter Yard - afreitag)7/15/2013 Same as last inspection. (DWR Sutter Yard - afreitag)4/18/2012 Concrete headwall is cracked, erosion behind headwall is also present. LS headwall needs to be repaired/replaced. Remove wooden debris from levee shoulder. (DWR UCIP - omagana)  
FIELD\_STRUCT\_DESC: [Richvale Irrigation Canal Siphon] 60-inch by 84-inch (5-foot by 7 foot) concrete irrigation conduit through the levee, 18.4 feet below the crown. Distribution box and walkway are located on the waterside (WS). Concrete headwall on the landside (LS). 28-foot reinforced concrete protective slab on top of the conduit in the center of the levee. [Additional Reference(s): DWR Levee Log, 1993. USACE Sacramento O&M Manual 519, June 1962 (HLM 8.95)]

Catwalk & gate located on WS. No daylight point on WS.

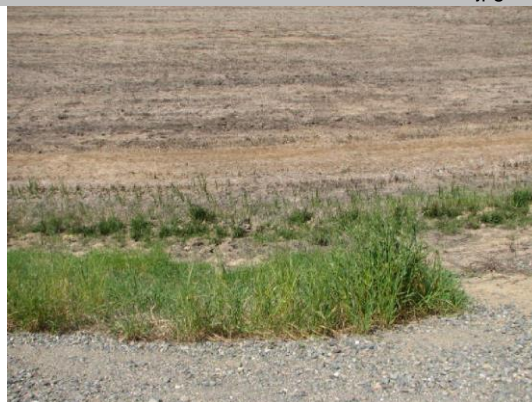
Photo 2 of 2 : UCIP\_FA\_2016\_48050\_66973.jpg

View of LS slope and toe. Unable to find welded plate on LS.

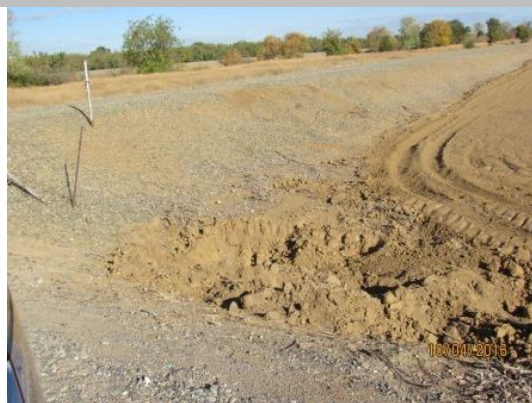
Photo 1 of 1 : FA\_2016\_MA0013\_301\_53\_20161014\_00102.jpg

View of ag tilling at the landside levee toe.

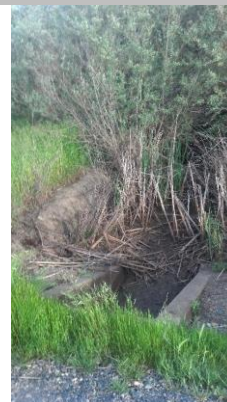
Photo 2 of 2 : UCIP\_FA\_2016\_47723\_67149.jpg

View of WS headwall with dense vegetation in channel.

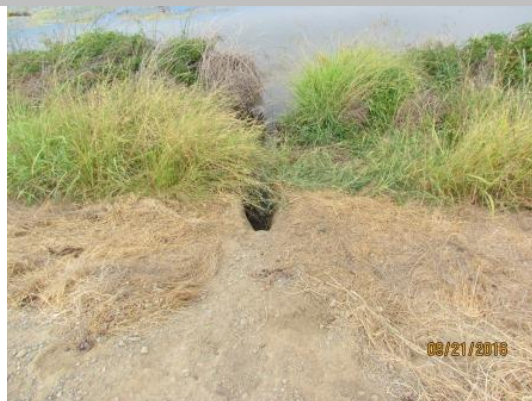
Photo 1 of 1 : FA\_2016\_MA0013\_301\_49\_20161014\_00104.jpg

View of the man made hole at the waterside levee toe.

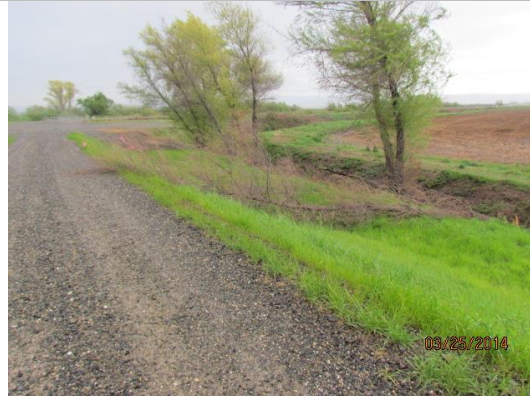
Photo 1 of 1 : FA\_2016\_MA0013\_301\_55\_20160823\_00014.jpg

View of the tree limbs on the landside slope and toe.

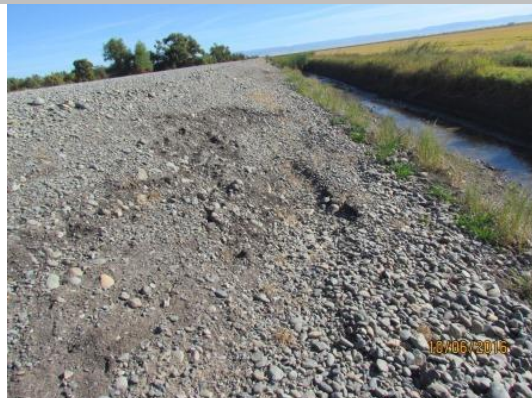
Photo 1 of 1 : FA\_2016\_MA0013\_301\_69\_20161014\_00109.jpg

View of slope instability issue along the landside slope.

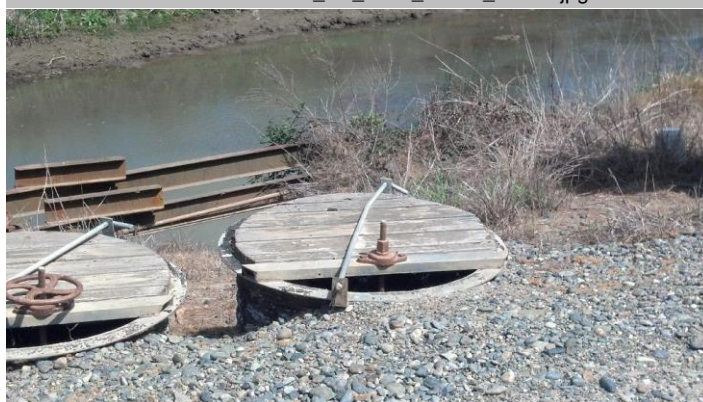
Photo 2 of 2 : UCIP\_FA\_2016\_49926\_67407.jpg

Corrugated metal pipe riser for pipe 1 of 3. Slide gate is missing handle.

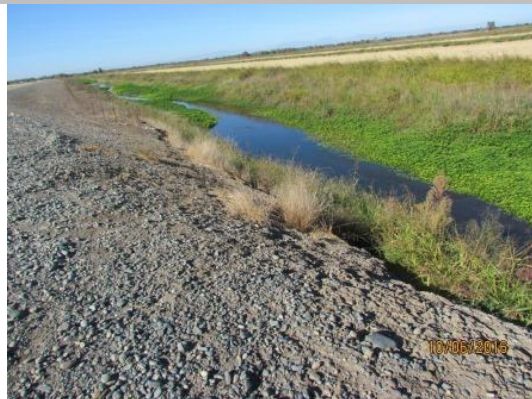
Photo 1 of 1 : FA\_2016\_MA0013\_301\_75\_20161014\_00114.jpg

View of the erosion along the waterside toe.

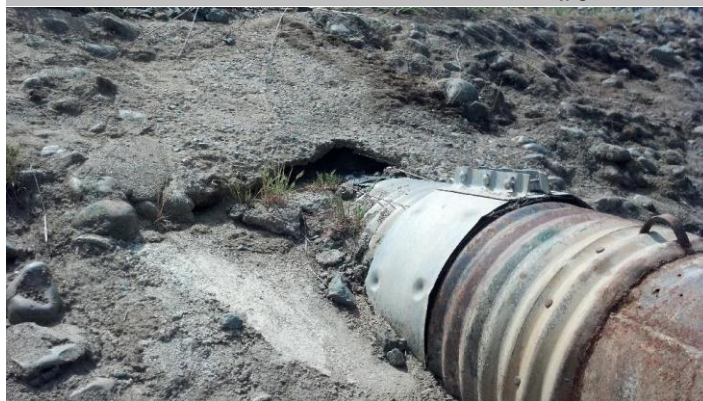
Photo 2 of 2 : UCIP\_FA\_2016\_48493\_67451.jpg

View of WS daylight. Hole present at pipe daylight.

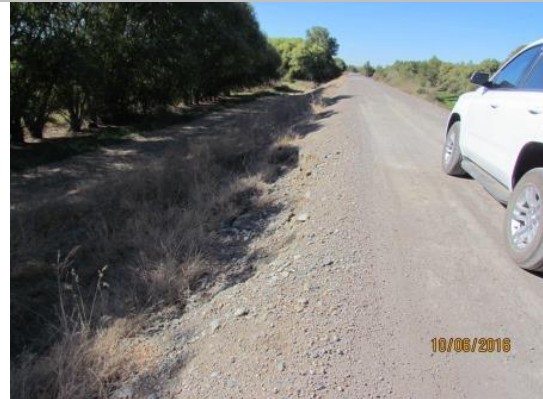
Photo 1 of 1 : FA\_2016\_MA0013\_301\_77\_20161014\_00116.jpg

View of slope instability issue along the landside slope.
